A REPORT ON THE UTILITY OF LIVESTOCK AND VEHICULAR UNDERPASSES

FINAL REPORT

LIVESTOCK AND VEHICULAR UNDERPASSES

Montana State Highway Commission

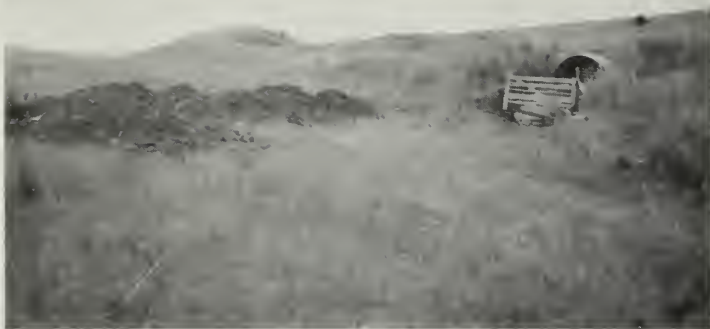
NORTH ENTRANCE, looking towards
Southeast; Notice fill material
cleaned out of pipe

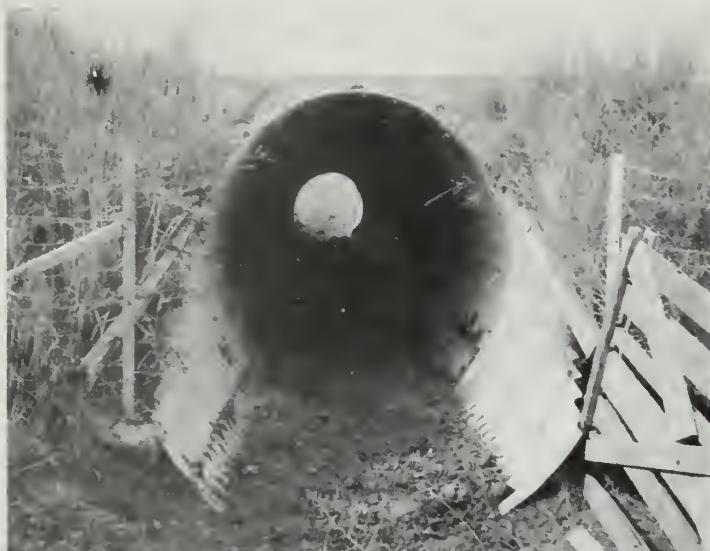
NORTH ENTRANCE: Notice pipe is mis-
shapen

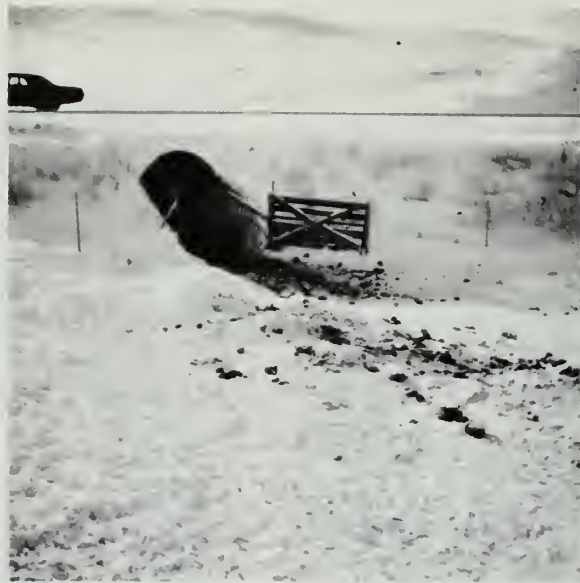
Case Study #55

North Entrance; photo taken January, 1971.
Livestock have been taking shelter during
snowstorms.

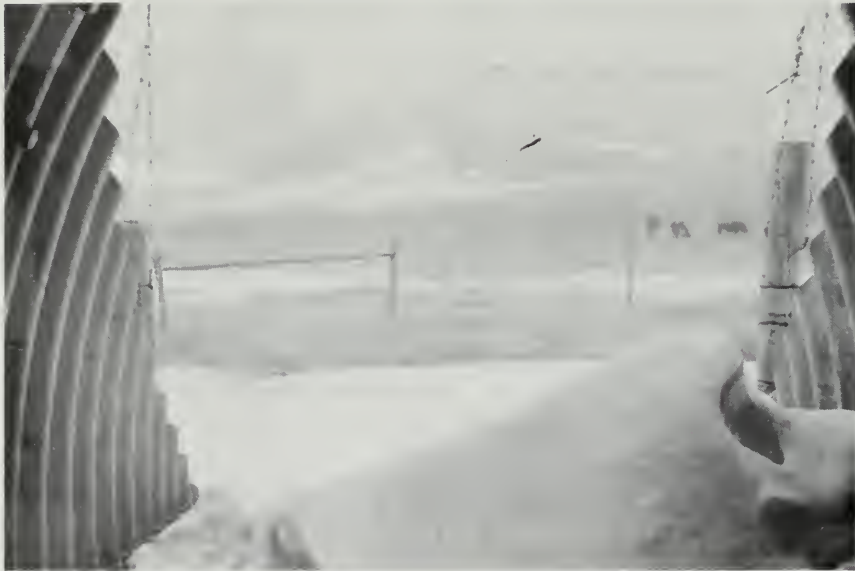
SOUTH ENTRANCE: Notice
drifting pattern.

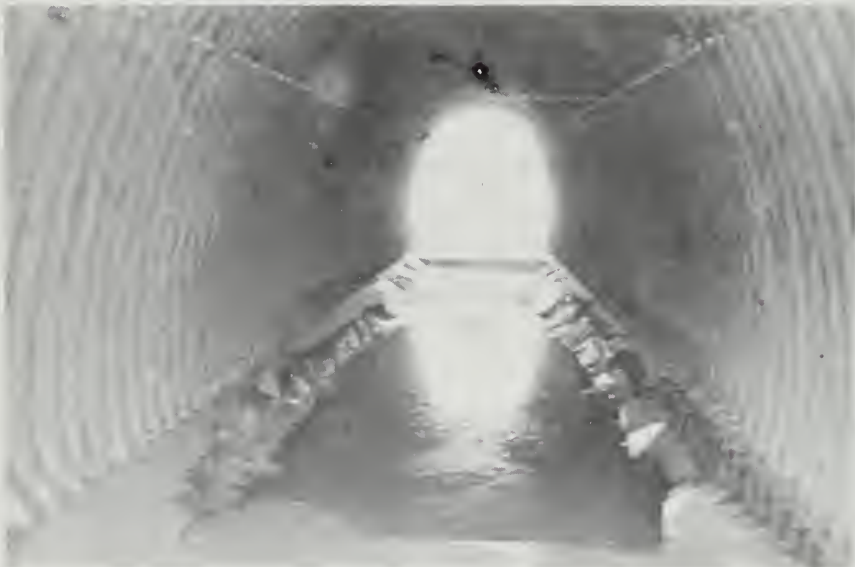
The ice inside the pipe had apparently broken from a warming trend, which melted the ice and lowered the water level by runoff. It is still dangerous footing for livestock and would not be considered usable in this condition. This underpass was also blocked by snow.

Inside of pipe
looking NORTH
Ice has broken
from lowering
water level.

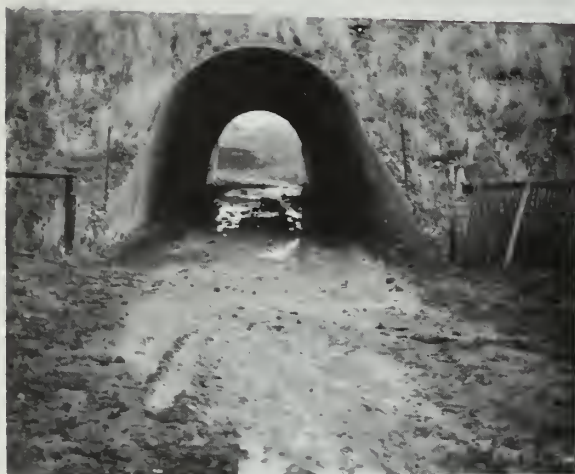
The above-mentioned large 17'3" span x 16'6" rise stockpass in Custer County has been a very expensive structure. This structure has caved in twice. The maintenance people tore it out and lowered it the first time; the second time, they repaired it by taking it completely apart and it was redone at the manufacturer's direction. It is even now beginning to settle and fold in again. A lot of the clearance was lost when this struc-

ture was lowered, as it has had to have additional material placed in the bottom, and silt with gravel washes in, making it extremely muddy when wet. The cost of materials, equipment and man hours has cost the maintenance forces approximately \$28,000.00 to \$30,000.00; however, should the structure go again, it will become the manufacturer's problem as they supervised the last repairs and it was done to their specifications. The maintenance forces have cleaned this structure out several times but there was no estimate of cleaning costs available. In conversation with the maintenance supervisor, a possible solution to this problem was a drain pipe alongside with drainage channels cut into and out of this flat area to handle the runoff.

Case Study No. 108
17'3" span x 16'6" rise x 124' long
Arch C.M.P., Stock-vehicle-drainage

NORTHWEST ENTRANCE-- Mud Conditions

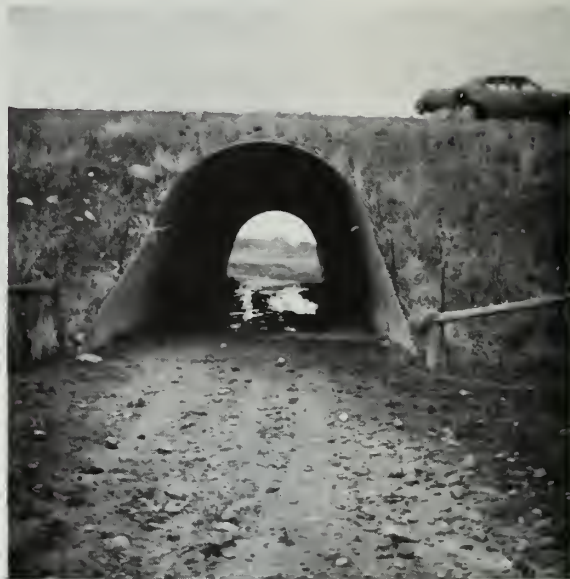
SOUTHEAST ENTRANCE-- Mud Conditions

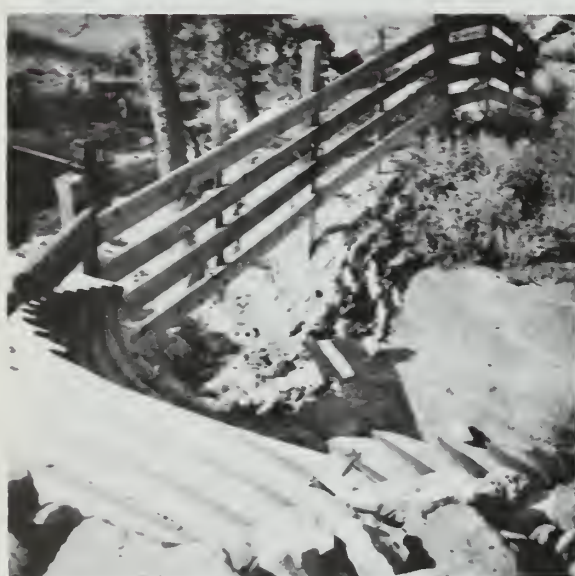
Case Study No. 104
7'3" span x 11'5" rise x 110' long
Squash C.M.P.; Drainage used for stock

Pavement Erosion at Outlet

There have been some drainage areas (about 2 out of 100) that have eroded the asphaltic surfaces of a combination structure. One recommendation by the same manufacturer's representative was to tie a wire mesh to the floor bolts and use cement for the floor mat, much like a building floor. This would be needed only in extreme circumstances. Perhaps some entrances should be built to specifications similar to those in a concrete lined canal and covered with "blown asphalt" (corrosion-proof membrane for metal pipes). These would adequately handle drainage, stock and vehicles.

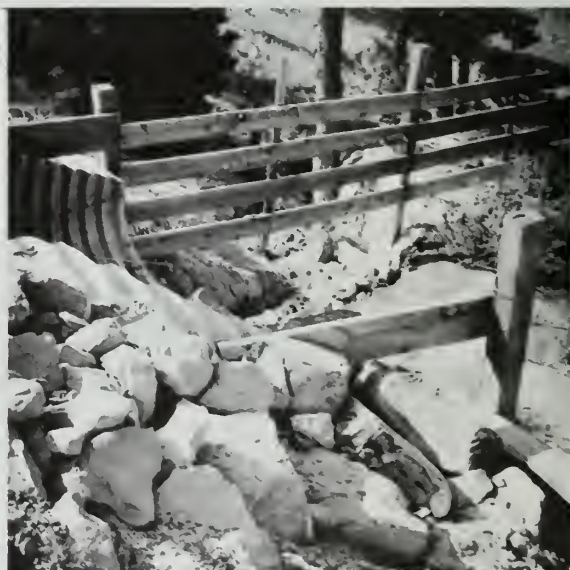
Pavement Erosion, Notice Drainage Channel cut.
